Home Inspection Report Summary

Property address:
122 West Street

THE HOME INSPECTION REPORT

Property Address:
Date of Inspection: 6/16/18 at 7:00 am
Client's Representative:

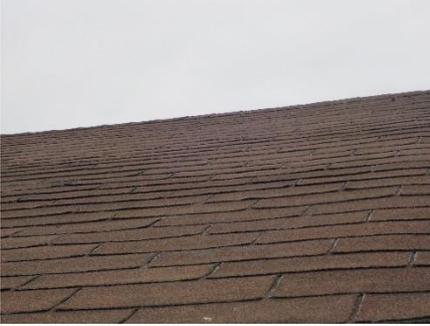
There are shingles comprised of asphalt / fiberglass material.

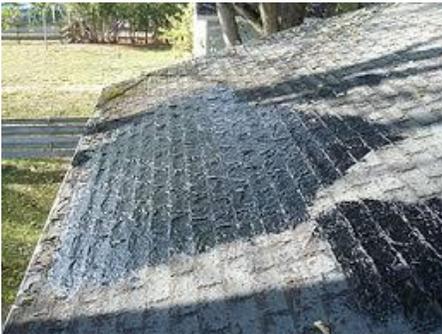
Condition

Roof appears to be in poor condition with obvious tar patching on south side of roof. Recommend roofing contractor.

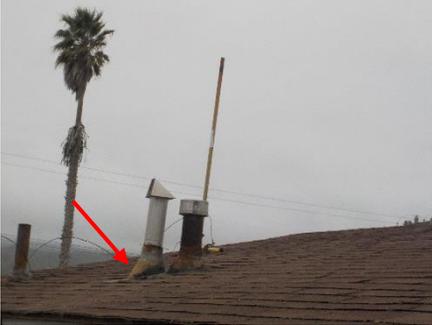
Flashings

The flashing around the vent stacks coming through the roof appear to be rusted. Replacement recommended when roof is replaced.

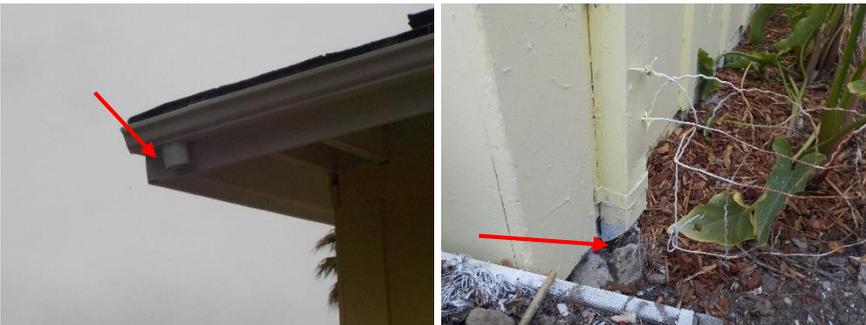
Gutters & Downspouts

There is a missing downspout on north east corner of house. Recommend installing and having water drain 5 feet from house to prevent water building up against house foundation.

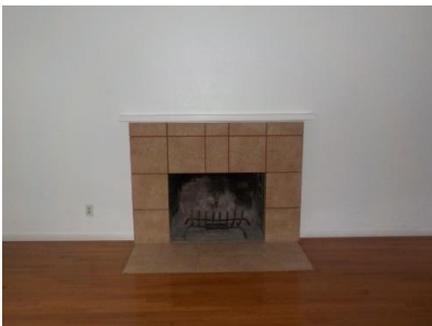
Fireplace Interior

The fireplace interior appears to be in functional condition. Major material defects were not apparent to me.

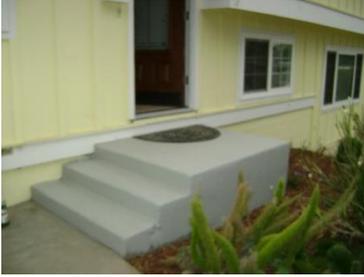
Steps & Handrails

Steps consisting of 3 or more require a handrail installed for safety along with a railing around the front landing. Recommend licensed carpenter for evaluation.

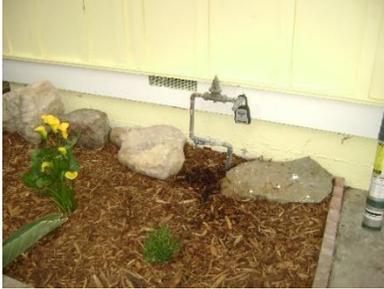
Exterior Hose bibs

Appears there may be leaking from the hose bib in front of the house. Monitor for leaking. All others are functional.

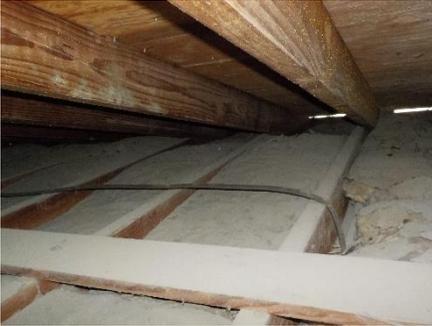
Primary Attic Space

Attic was accessed from panel at the top of the stairs. Less than adequate insulation observed.

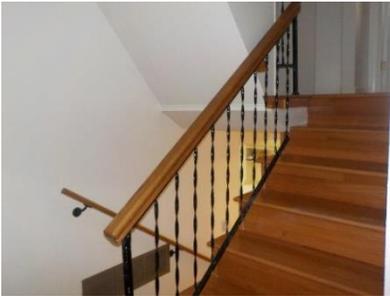
Handrail going up to second level is loose. Recommend a licensed carpenter.

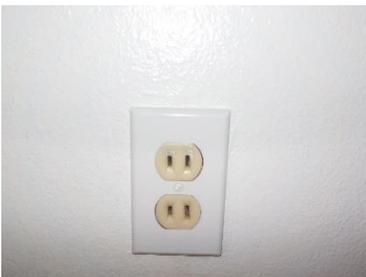
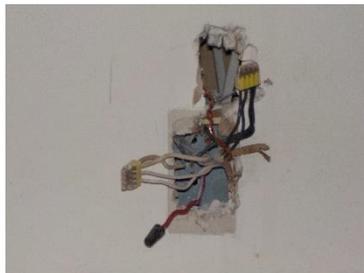
Receptacles

All tested open ground and poses a shock hazard. Exposed wiring inside cabinet. Recommend consulting a licensed electrician.

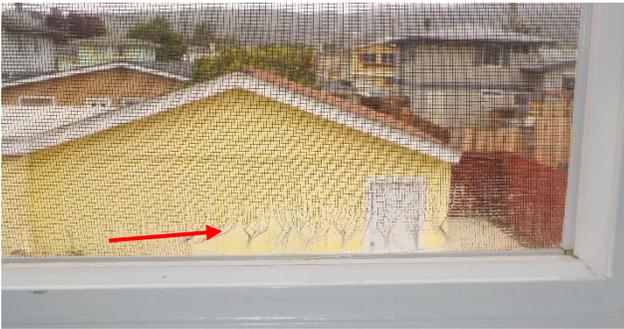
Windows

Both windows open and close smoothly but screen on south window is ripped. Recommend replacement.
