Home Inspection Report Summary

Property address:
122 West Street

THE HOME INSPECTION REPORT

Property Address:
Date of Inspection: 6/16/18 at 7:00 am
Client's Representative:

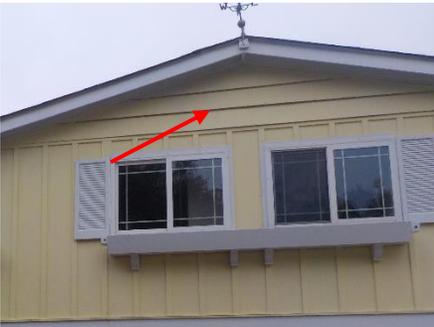
Ventilation

There are horizontal slats for ventilation of the attic on north and south side of house. **GOOD**

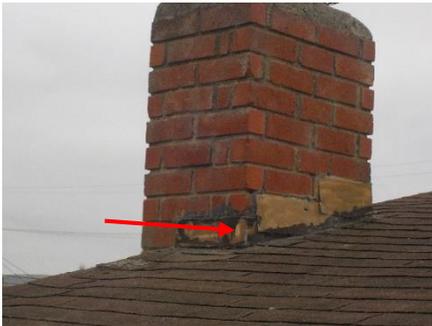
Chimney Flashings

A representative number of areas of chimney flashing were inspected. There is visible metal flashing installed around the chimney(s), where the chimneystack intersects the roof covering material.

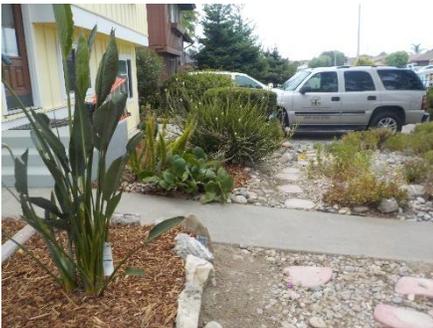
The general grading around the house foundation perimeter appears functional. Ideally the grading should slope about 6% over the first 10 feet away from the house foundation. Monitoring during a rainstorm is recommended.

GOOD

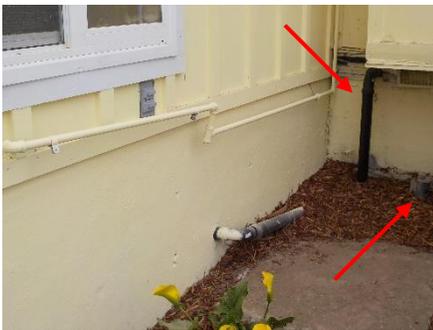
Drainage Grates or Drain Pipes

Drain pipe present next to drain clean out. **GOOD**

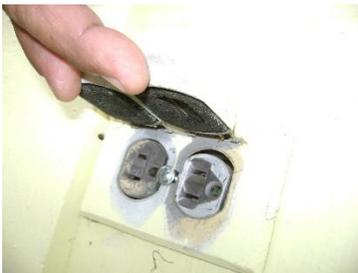
Receptacles & GFCIs

The exterior receptacles that were tested are functional and include ground-fault protection. **GOOD**

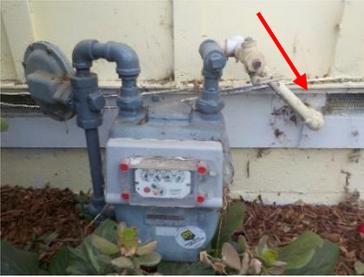
Public Gas Meter

The main gas shut-off valve is located near the gas meter at the east side of the house. Meter looks to be in good condition, no surface rust and stable. **GOOD**

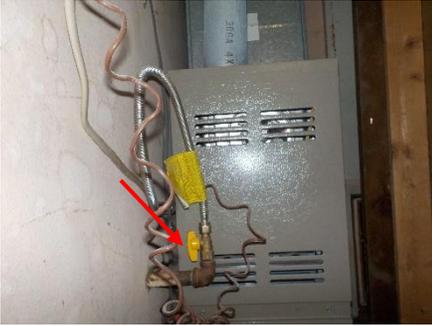
Gas shut-off valve

There is a gas shut-off valve near the heating system.

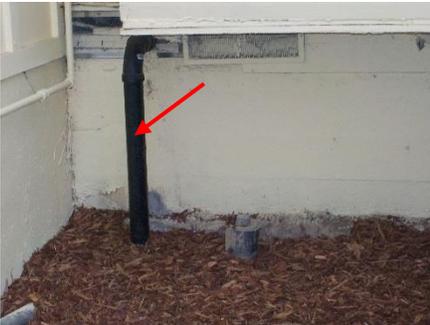
Type of Material

Visible portions of the drainpipes are of PVC, poly vinyl chloride. Very commonly used material. Not all of the drain pipes were readily visible. Much of the pipes are inside the walls.

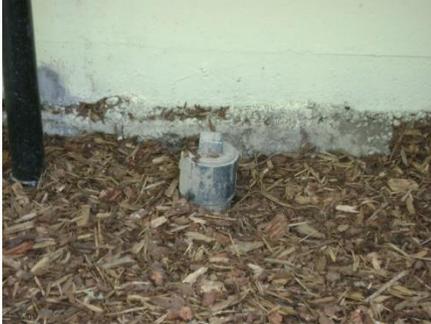
Condition of Drain Waste & Vent Pipes

No major problems with the visible waste and drainage pipes are apparent. Good.

Clean-out fitting is visible.

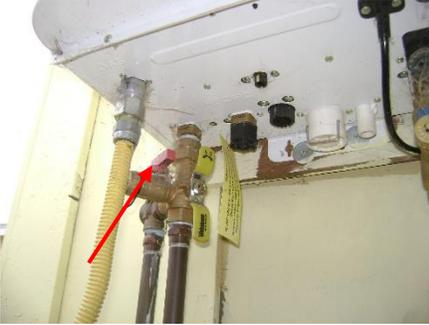
Water Shut-Off Valve & Connectors

The water shut-off valve is installed. Not leaking. This valve turns off the cold-water supply to the tank. **GOOD**

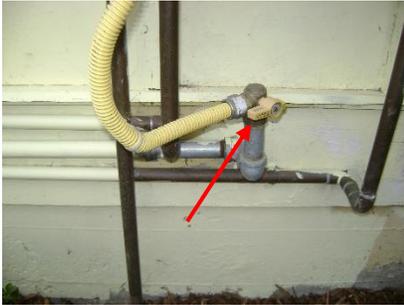
Gas Shut-Off Valve

The gas shut-off valve at the water heater is installed within reach of the tank. This valve turns off the gas supply to the tank. **GOOD**

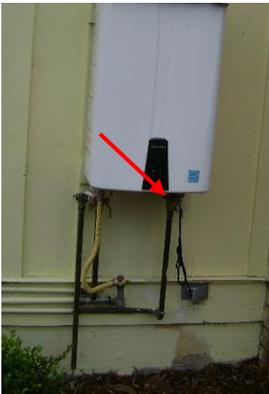
Relief Valve & Discharge

The water heater is equipped with a pressure-temperature relief valve. **GOOD**

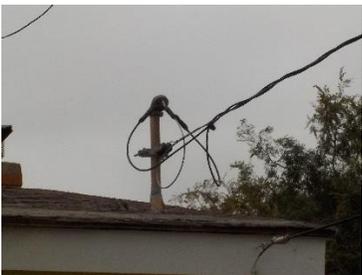
Main Electric Service Line

The main electric service line is above ground.

The line appears to be in good shape. No major damage. **GOOD**

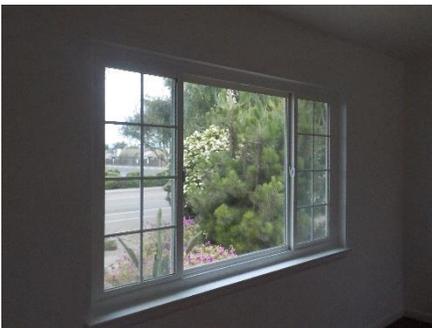
Windows open as designed. Screens installed and in good condition. **GOOD**
